**Re: 66 Mill Court, Rutherglen, G73 2SF**

We write to confirm the results of our initial examination of the property on 8 May 2024. This non-invasive survey was carried out by our Mr Colin Wilks following your e-mail instruction of 30 April 2024.

The property is a brick built ground floor flat in 3-storey block.

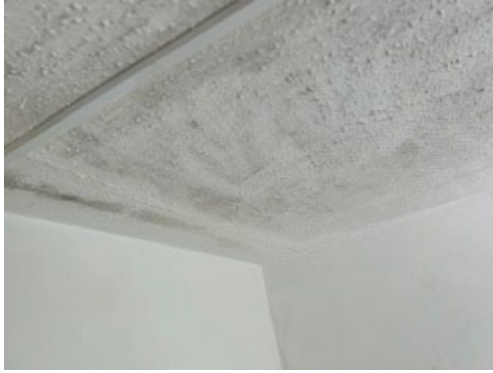
The wall/ceiling surfaces to various areas throughout the property were noted to be affected by black spot mould due to excessive condensation. Condensation occurs when warm moisture-laden air, cools to 'dew-point' (the temperature at which moisture condenses) against a cold surface. Intermittent heating and insufficient ventilation provide ideal conditions for condensation. As such, proper heating and ventilation must be maintained, to reduce moisture available for evaporation into the air within the property and condensing on the cold wall surfaces.

The wall/ceiling surfaces as stated are all plastered on the hard thus creating a very cold surface and a surface ideal for the formation of condensation and subsequent mould growth. Ideally these surfaces would be "warmed up" with the introduction of a layer of insulation. This can, in turn, lead to issues with the re-fitting of existing floor coverings, window trims, window ingoes and skirtings/facings however we can provide costs for this provision should it be required.

Mould growth due to condensation to ceiling to room rear left

It is assumed that regular, daily air changes are not being carried out. This allows for stale, moisture filled air to be removed and replaced with fresh, clean air and thus reduces the amount of moisture within the property liable to condense on the cold surfaces.

A low, constant warmth should be applied at all times. Fluctuations in temperature can cause condensation to occur as every time the heating goes off and the temperature drops, the air cannot sustain the moisture and it will condense on the cold surfaces.

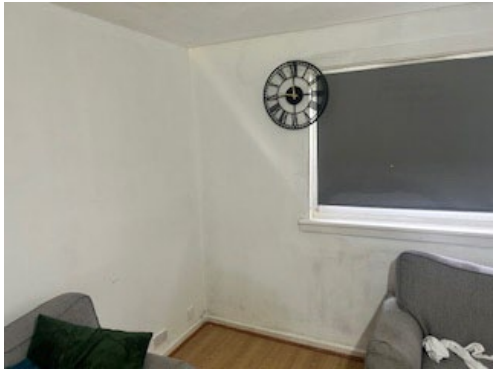
Mould growth due to condensation to walls to room rear left

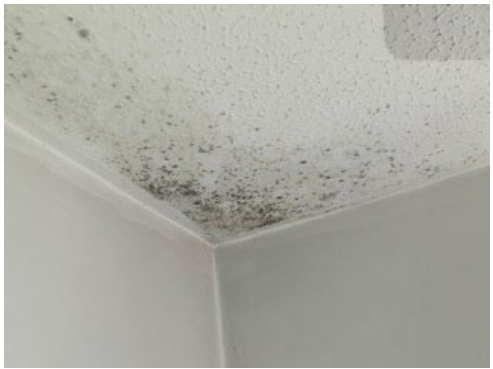
Mould growth due to condensation to ceiling to room front right

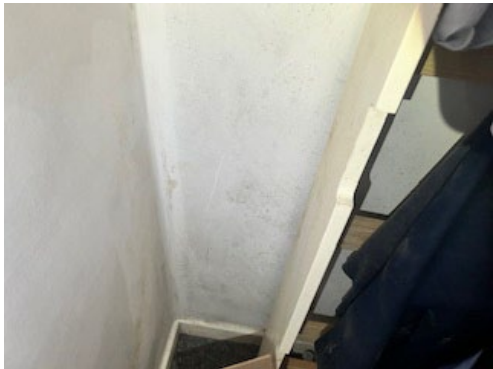
Mould growth due to condensation to walls to room front right

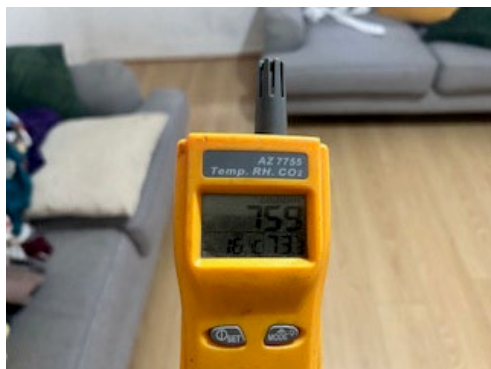
High levels of relative humidity to room rear left

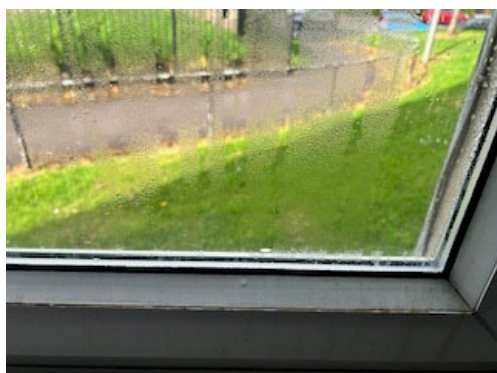
Condensation to window to room rear centre
