**Re: 66 Mill Court, Rutherglen, G73 2SF**

We write to confirm the results of our initial examination of the property on 8 May 2024. This non-invasive survey was carried out by our Mr Colin Wilks following your e-mail instruction of 30 April 2024.

The property is a brick built ground floor flat in 3-storey block.

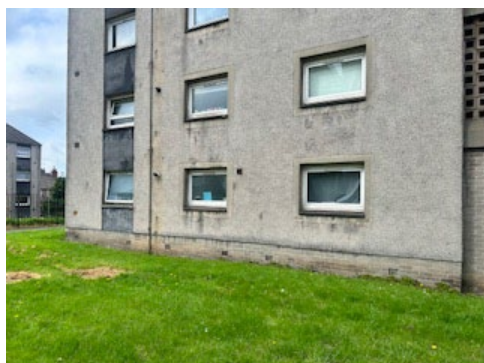
Front elevation

At the time of our initial inspection, it was dry and warm. In view of the fine weather conditions it was not possible to accurately comment as to the efficacy of the existing rainwater goods.

- Cracked concrete window sills to some windows.
