# Home Report

# Single Survey

<b>Property address</b>	55 Menzies Avenue Cumnock East Ayrshire KA18 3DE
<b>Customer</b>	████████████████████
<b>Customer address</b>	55 Menzies Avenue Cumnock East Ayrshire KA18 3DE
<b>Prepared by</b>	Select Surveyors Ltd
<b>Date of Inspection</b>	14 <sup>th</sup> September 2023

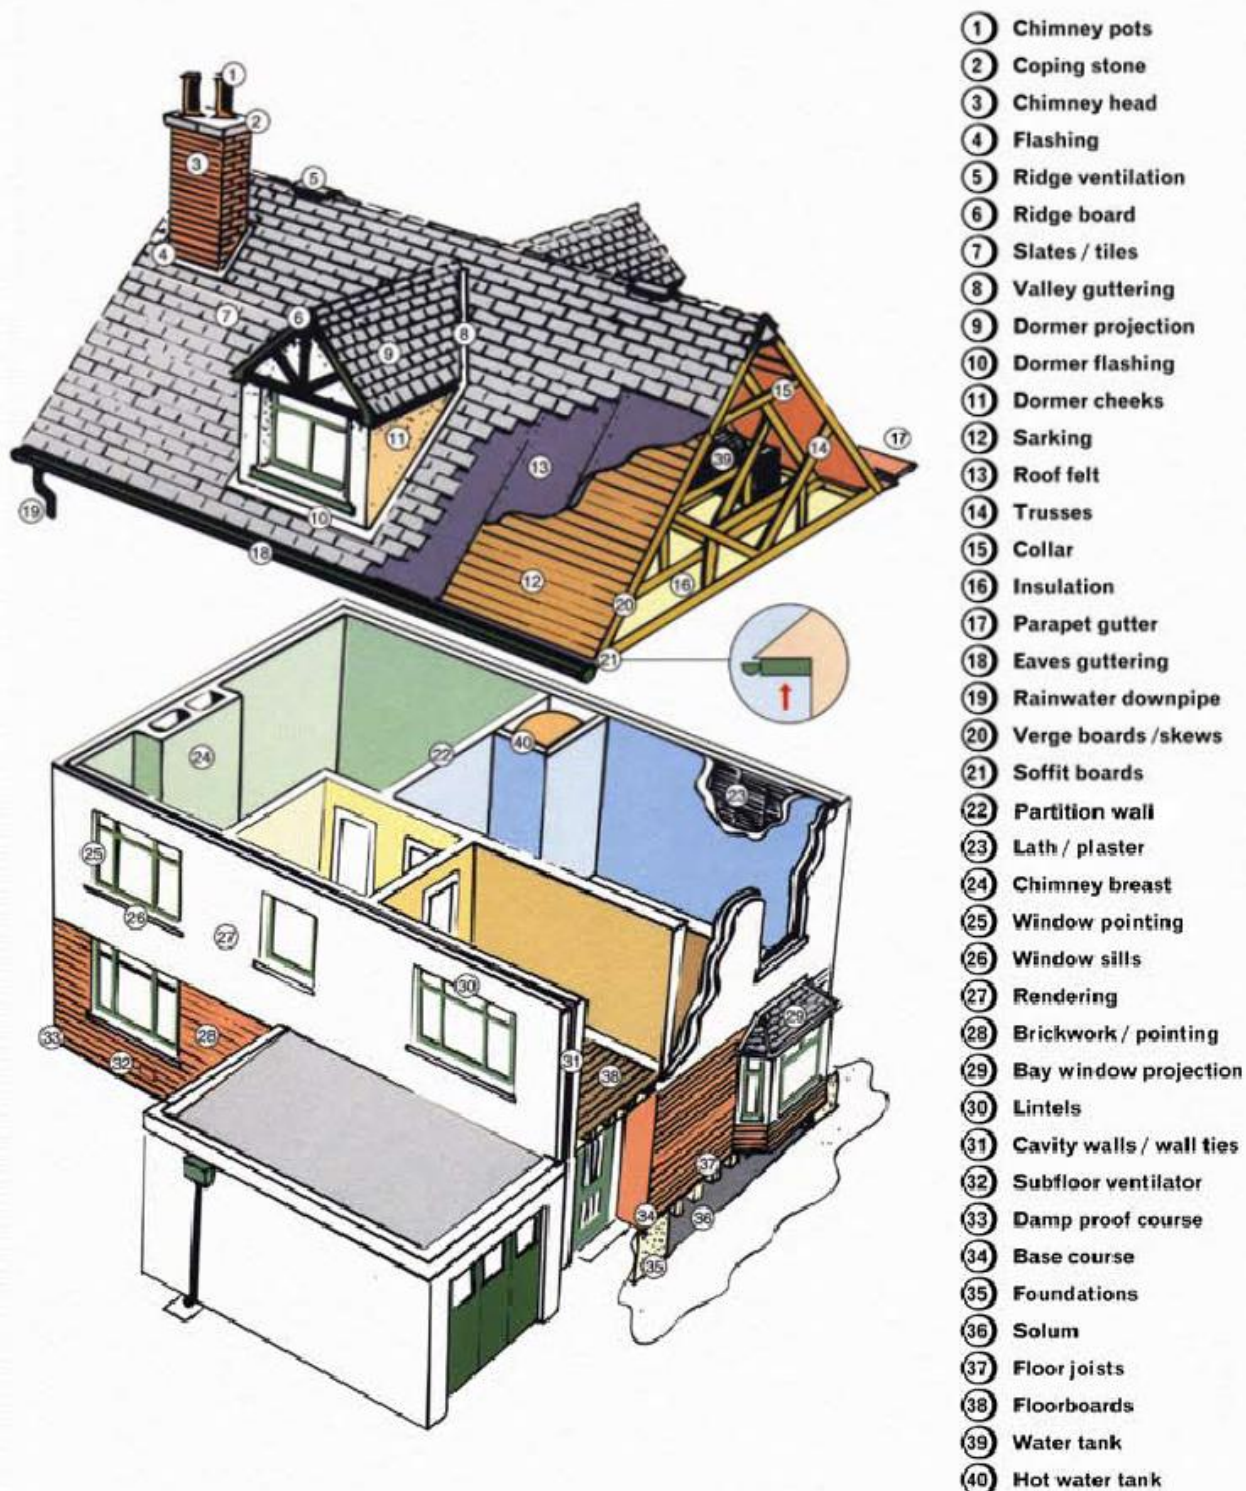
## Sectional Diagram showing elements of a typical house

Reference may be made in this report to some or all of the above component parts of the property. This diagram may assist you in locating and understanding these items.

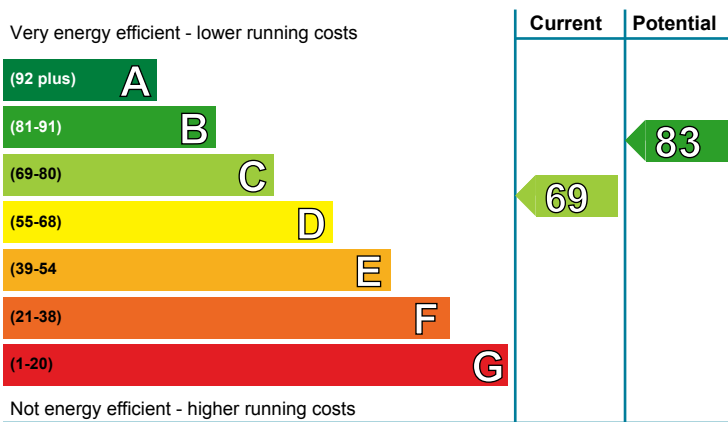
## Energy Efficiency Rating

This graph shows the current efficiency of your home, taking into account both energy efficiency and fuel costs. The higher this rating, the lower your fuel bills are likely to be.

Your current rating is **band C (69)**. The average rating for EPCs in Scotland is **band D (61)**.

The potential rating shows the effect of undertaking all of the improvement measures listed within your recommendations report.

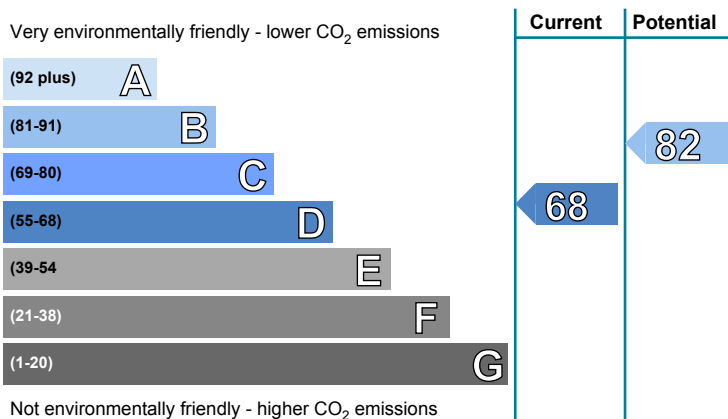
## Environmental Impact (CO<sub>2</sub>) Rating

This graph shows the effect of your home on the environment in terms of carbon dioxide (CO<sub>2</sub>) emissions. The higher the rating, the less impact it has on the environment.
