Home Report

Property address	71 John Allan Drive Cumnock Ayrshire KA18 3AG
Customer	
Customer address	241 Kilmarnock Road Shawlands Glasgow G41 2JF
Prepared by	Select Surveyors Ltd
Date of Inspection	18 th March 2024

Description	The property is a purpose built upper cottage flat in a two storey block of four flats.
Accommodation	The accommodation comprises of : Entrance hall, living room, kitchen, two bedrooms and bathroom.
Gross internal floor area (m²)	Approximately 66 M ²
Neighbourhood and location	The property is situated in an established and popular residential area of Cumnock, Ayrshire. Surrounding properties are of a similar age and type. Local amenities, schooling and transport links are available. Properties are a mixture of private and local authority housing.
Age	Built circa 1950's
Weather	Weather was dry/overcast at the time of inspection. During dry weather we cannot confirm that the rainwater goods are totally serviceable or that flashings etc are water tight.
Chimney Stacks	Visually inspected with the aid of binoculars where appropriate. Chimney stacks are of brick built construction finished with render.

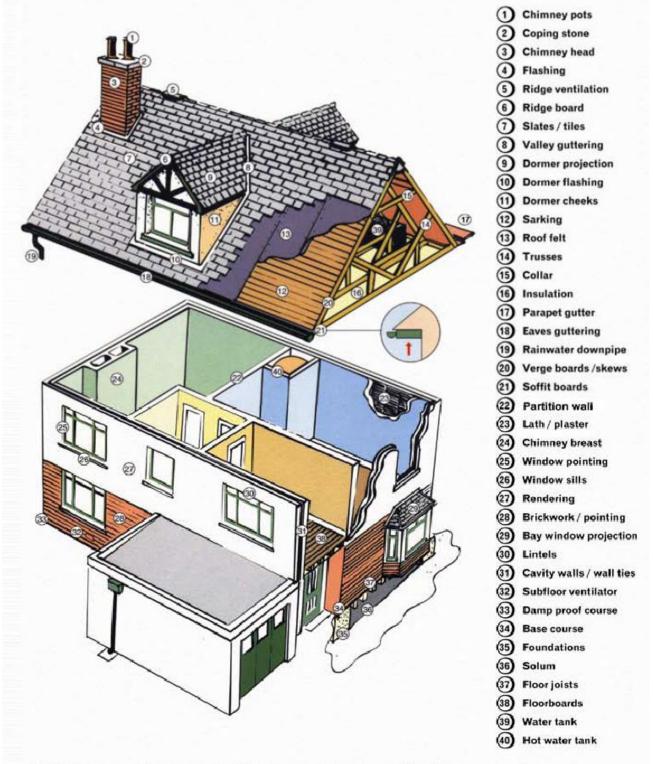
Sectional Diagram showing elements of a typical house

Reference may be made in this report to some or all of the above component parts of the property. This diagram may assist you in locating and understanding these items.
