HOME
report

SINGLE SURVEY
ENERGY REPORT
PROPERTY QUESTIONNAIRE
VALUATION REPORT

Survey report on:

Property Address	2 Green Street Darvel KA17 0AY
Customer	Mr V Bamgbowu
Date of Inspection	05/04/2024
Prepared by	Thomas O'Kane Harvey Donaldson & Gibson Chartered Surveyors

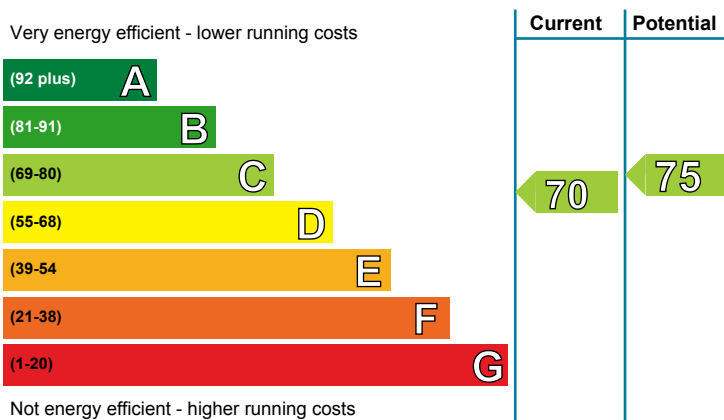
Energy Efficiency Rating

This graph shows the current efficiency of your home, taking into account both energy efficiency and fuel costs. The higher this rating, the lower your fuel bills are likely to be.

Your current rating is **band C (70)**. The average rating for EPCs in Scotland is **band D (61)**.

The potential rating shows the effect of undertaking all of the improvement measures listed within your recommendations report.

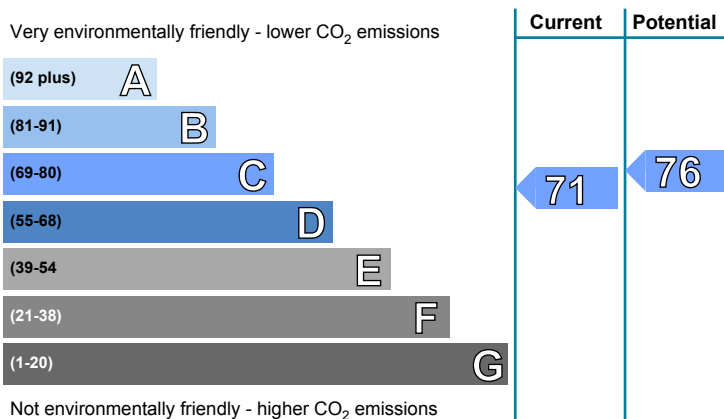
Environmental Impact (CO₂) Rating

This graph shows the effect of your home on the environment in terms of carbon dioxide (CO₂) emissions. The higher the rating, the less impact it has on the environment.
